Project Number: 222-141

**Subject: Petrini Place, CA – SB 326 EEE Inspection Report
2001 McAllister Street, San Francisco, CA**

**Subject: SB 326 EEE Inspection Completion Report
Petrini Place, 2001 McAllister Street, San Francisco, CA**

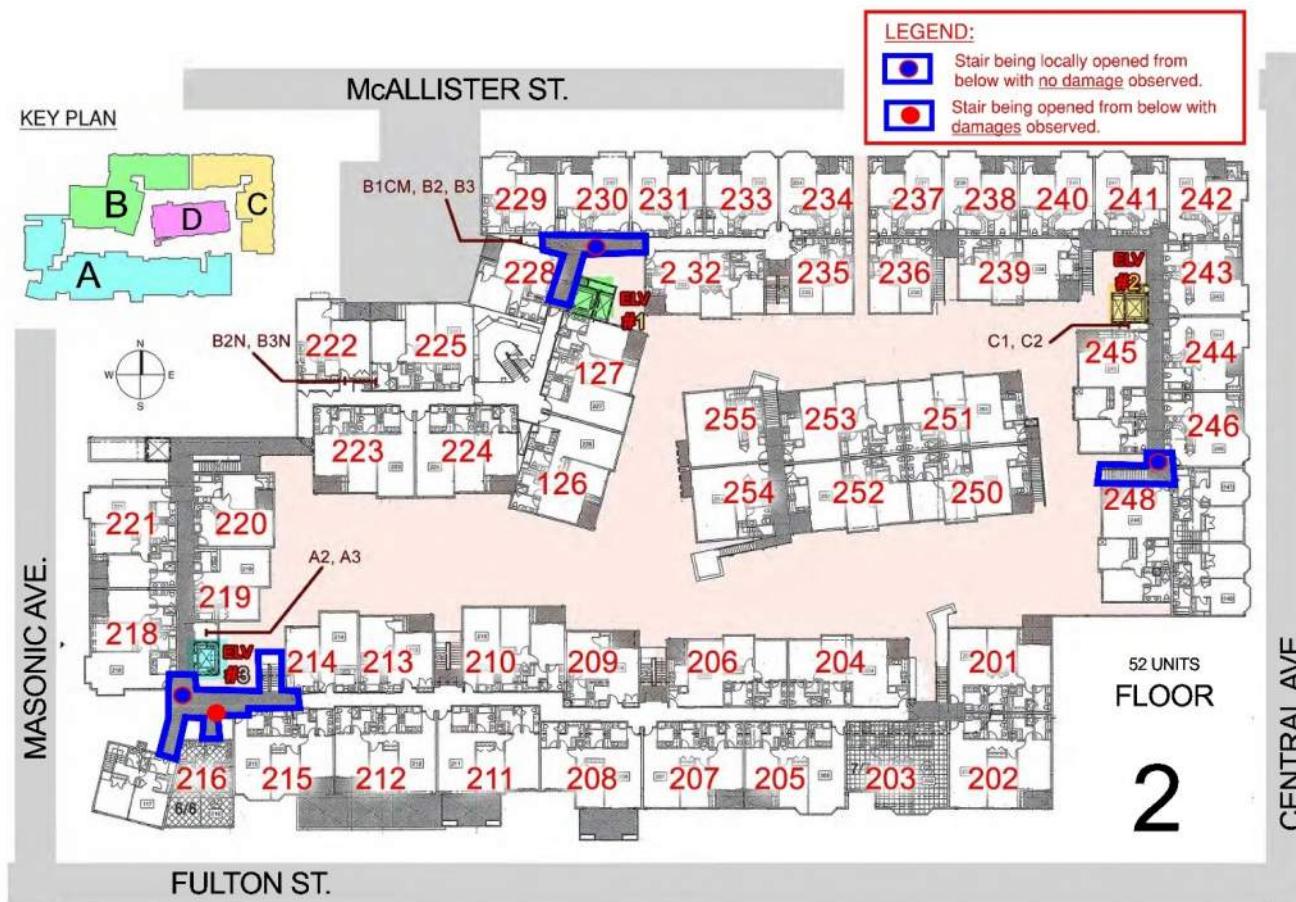
Second Floor Site Plan Showing The Walkways Being Locally Opened

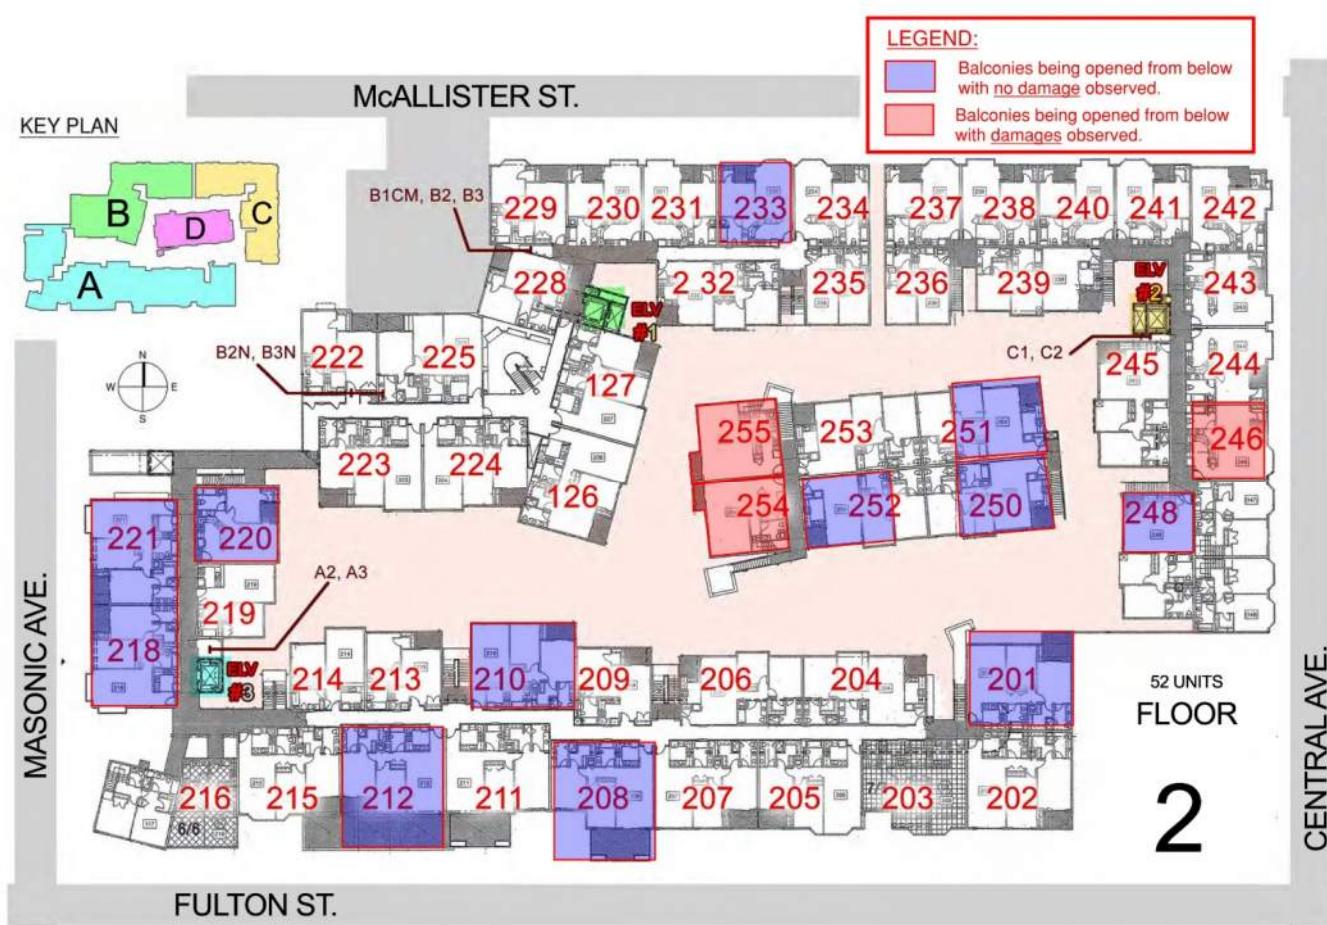
Second Floor Site Plan With The Units Being Opened

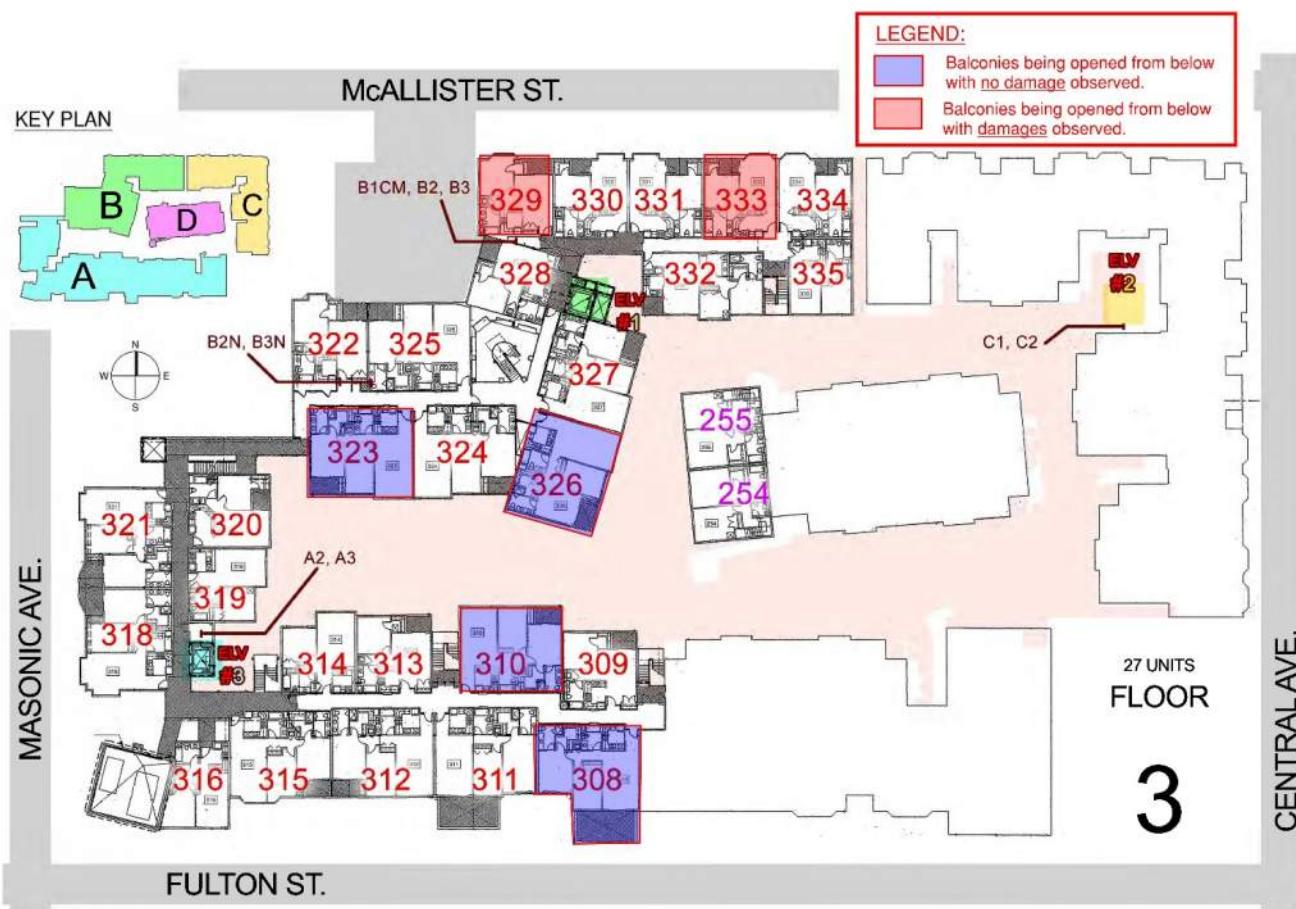
Third Floor Site Plan With The Units Being Opened

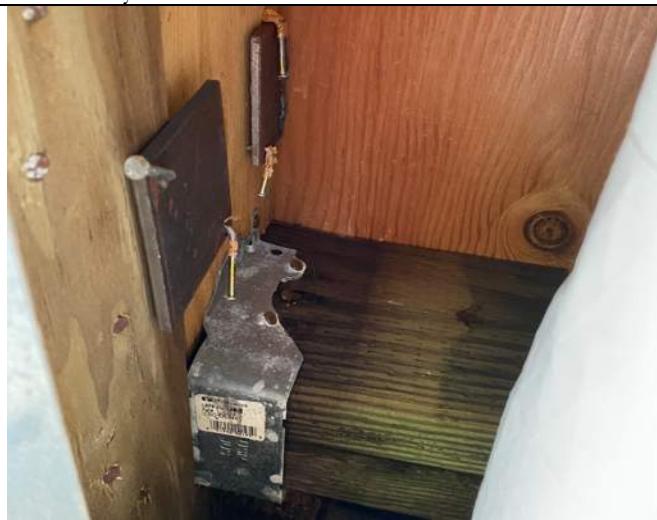
66: Stair by Unit 248

Stairs	Damage Observed	Repair Recommendation
by Unit #201	Rusted Steel plates below concrete thread	See 3.2.1.1
by Unit #210	Rusted steel plates below concrete thread & rusted steel stringer	
by Unit #236	Rusted Steel plates below concrete thread	
by Unit #248	Rusted handrails and blusters	
by Unit #250	Rusted Steel plates below concrete thread

3.2.1.2. Rusted handrails and blusters and stair stringer. Clean rusted steel in accordance with the SSPC-SP15 standard, and apply zinc-based primer and protective finish coating to the repair area.

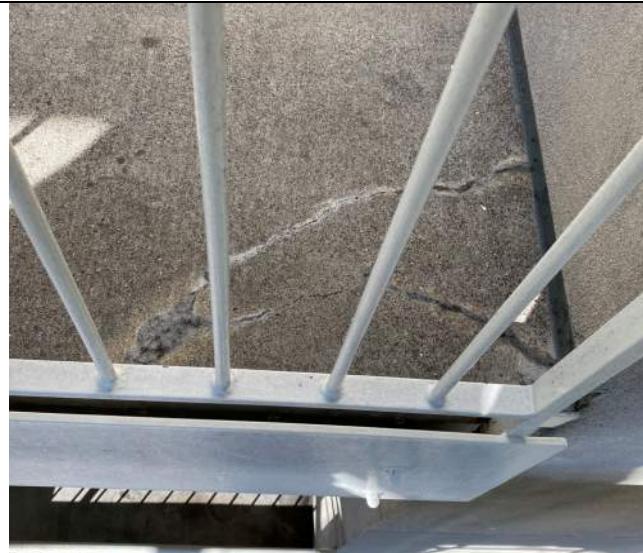
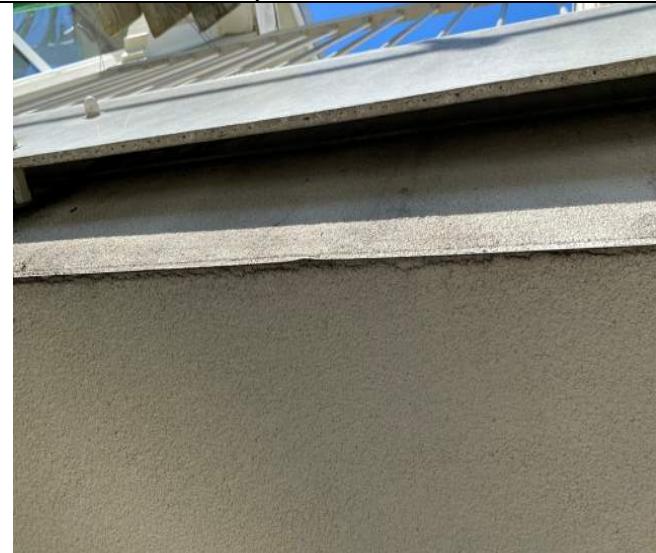
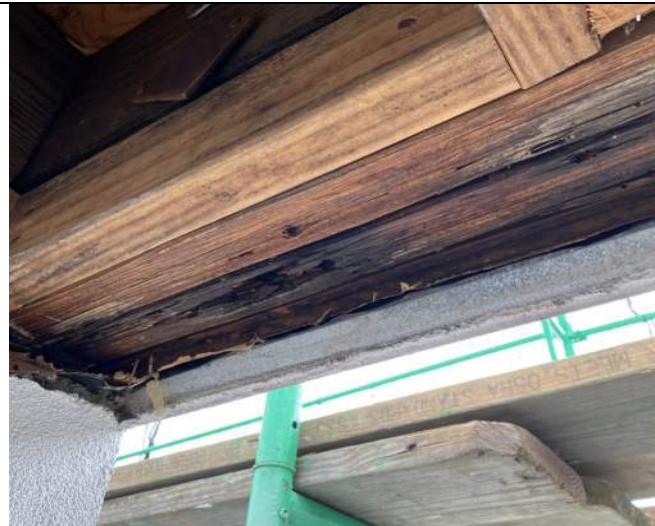
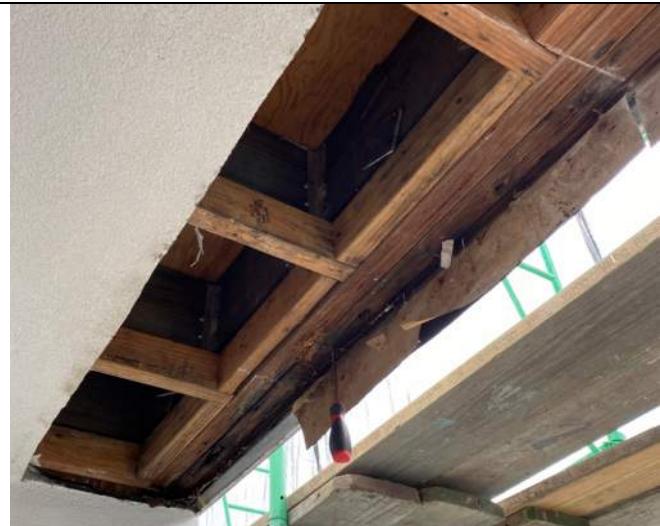
101: Unit 246 Balcony

102: Unit 246 Balcony

103: Unit 246 Balcony

104: Unit 246 Balcony

- 3.1.3. In our opinion, the observed conditions for the damaged balconies listed in Appendix A present an immediate threat to the health and safety of the residents. MBC recommends immediate shoring at the balconies of units 246, 254, 255, 329, and 333 until repairs are completed. This is due to extensive beam damage observed at the edge beams.

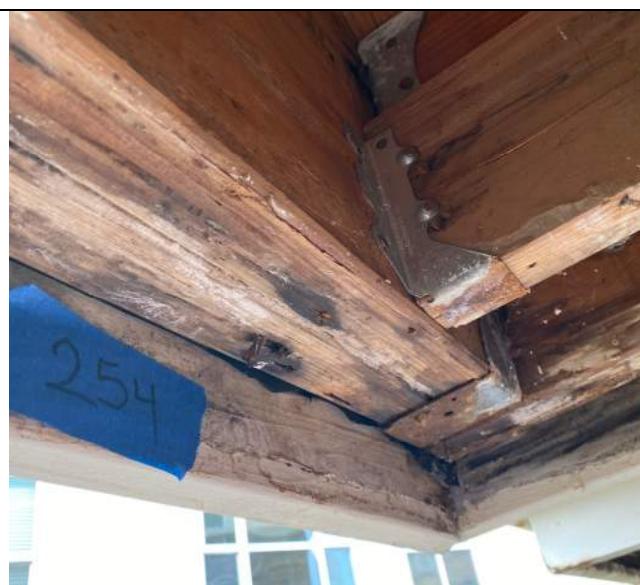
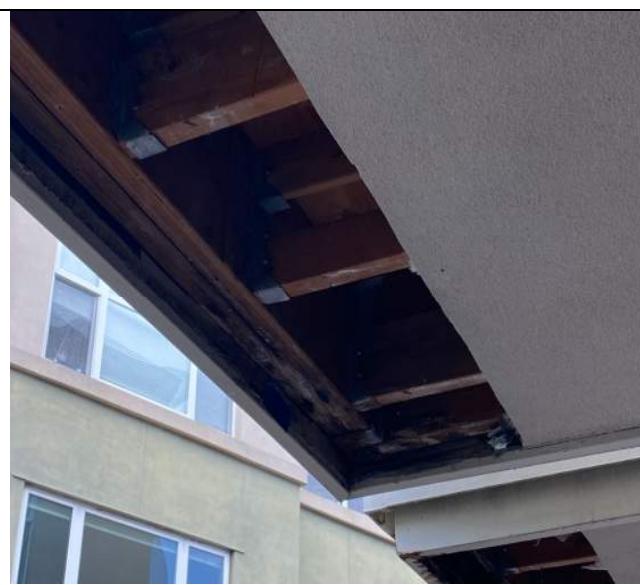
125: Unit 254 Balcony

126: Unit 254 Balcony

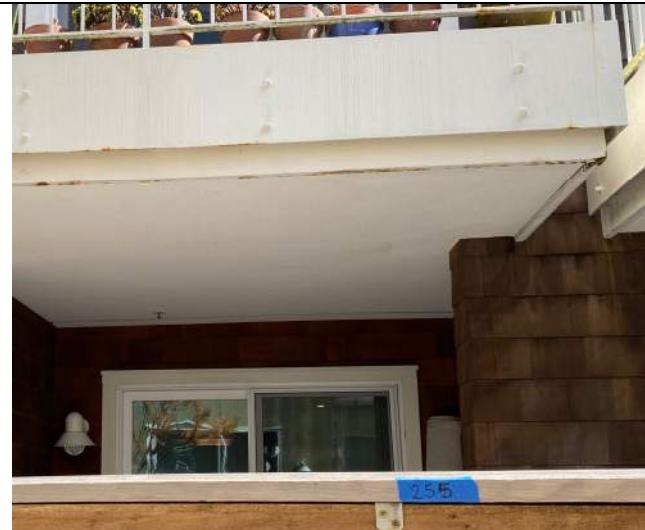
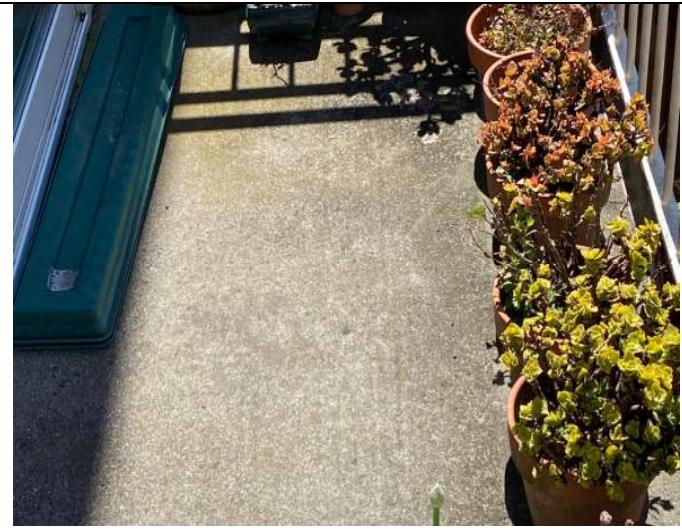
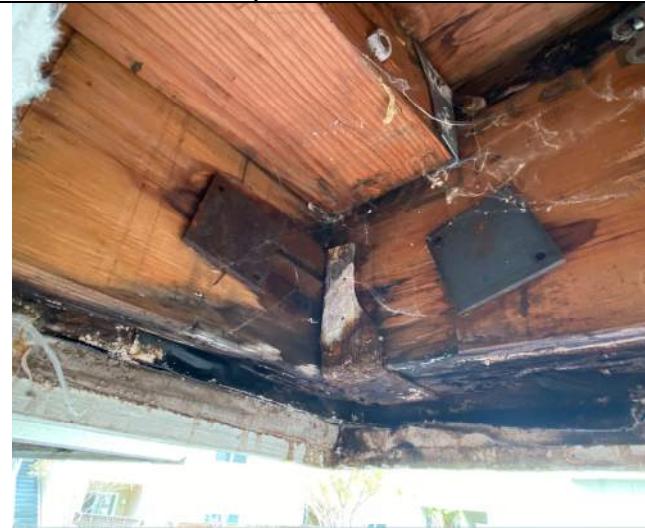
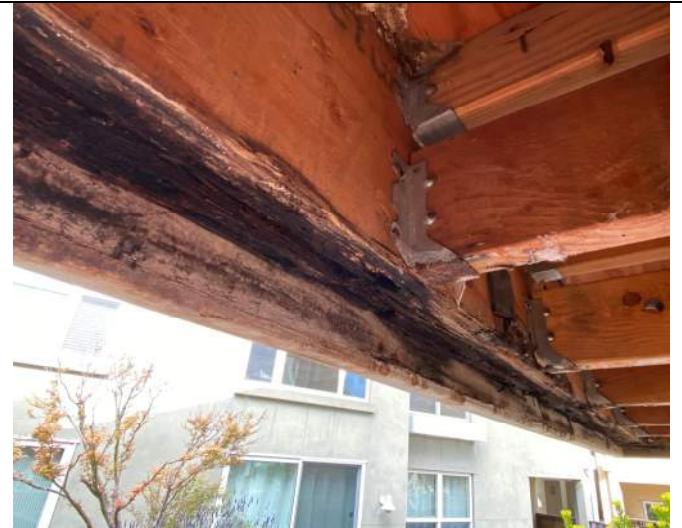
127: Unit 255 Balcony

128: Unit 255 Balcony

129: Unit 255 Balcony

130: Unit 255 Balcony

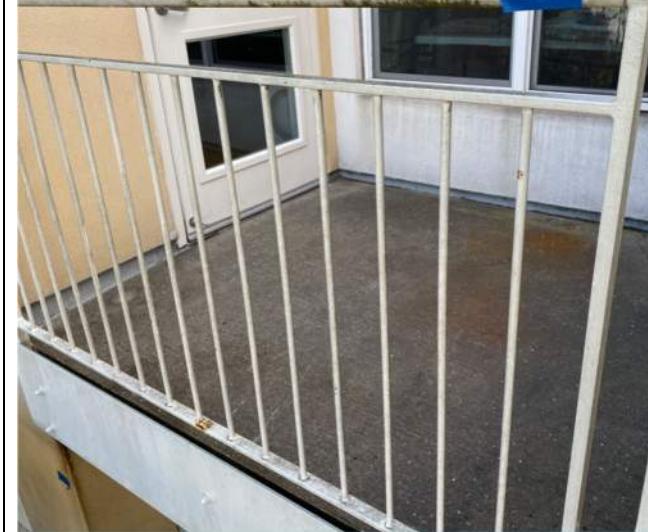
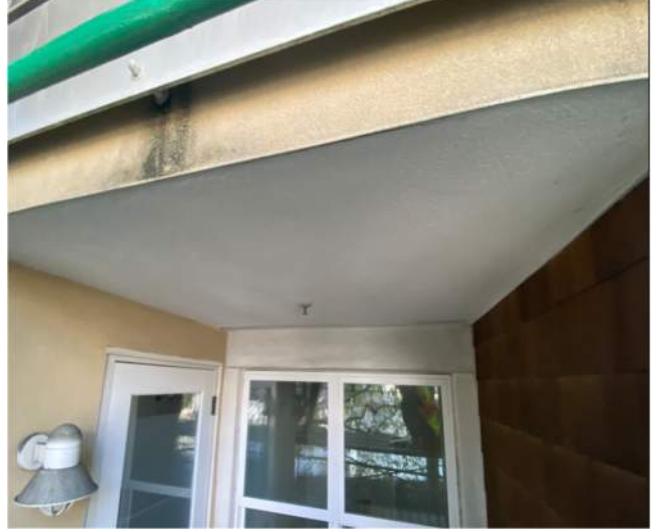
187: Unit 333 Balcony

188: Unit 333 Balcony
