Project Number: 222-141

**Subject: Petrini Place, CA – SB 326 EEE Inspection Report
2001 McAllister Street, San Francisco, CA**

**Subject: SB 326 EEE Inspection Completion Report
Petrini Place, 2001 McAllister Street, San Francisco, CA**

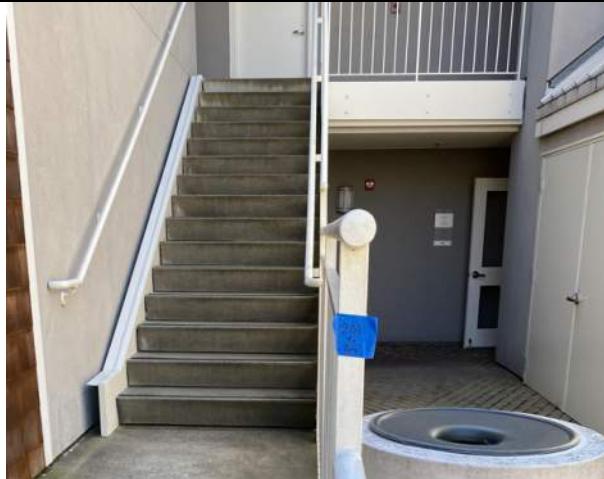
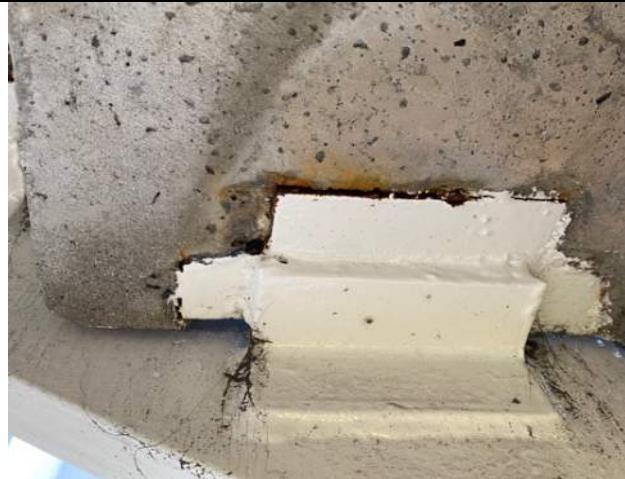
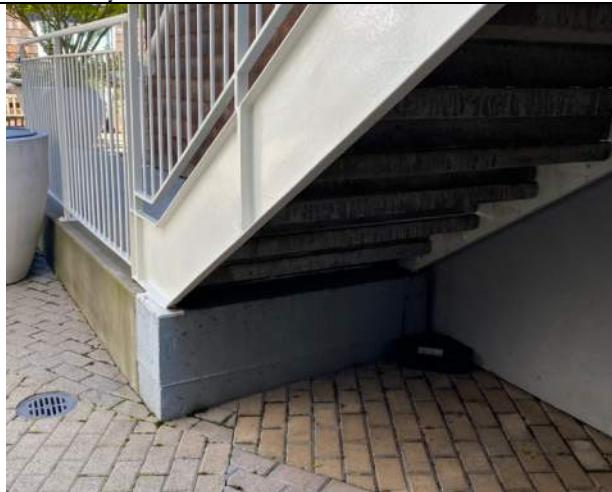
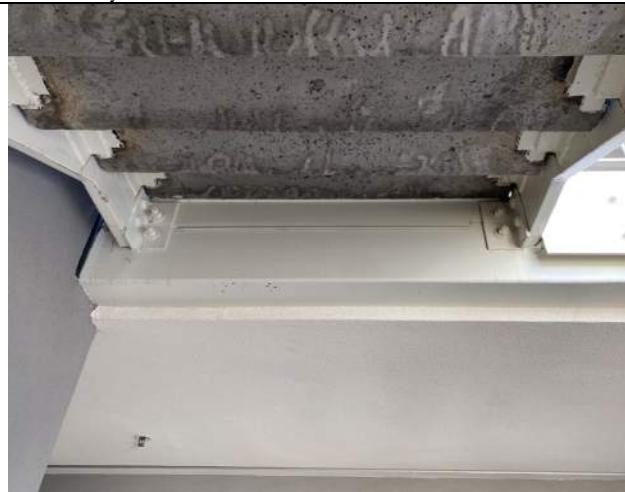
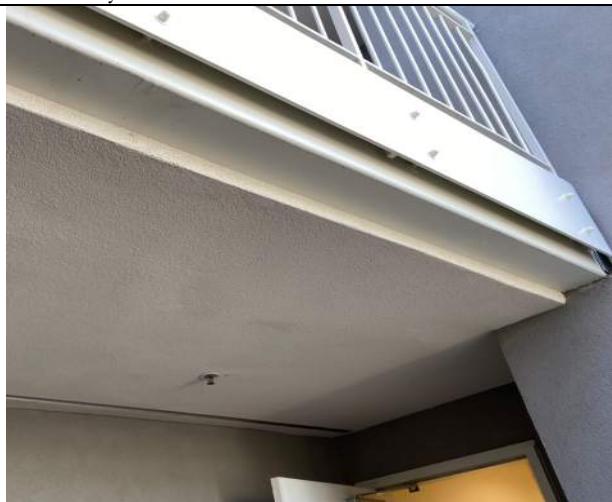
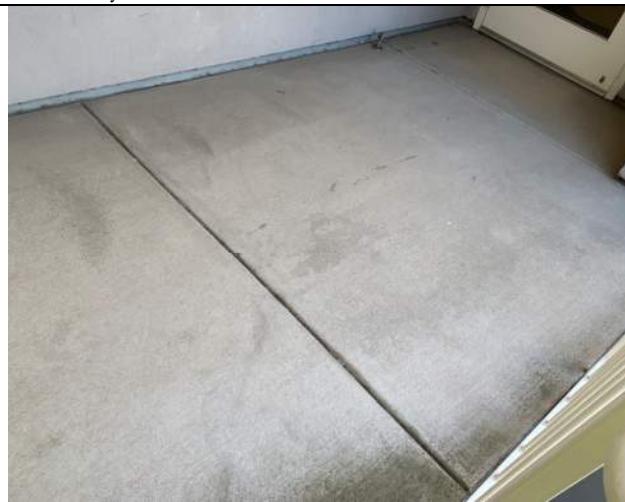
1: Stair by Unit 201

3.2.1.1. Corrosion signs at the connection between the embedded steel plates below the precast threads and the steel angle supporting the threads. Clean rusted steel in accordance with the SSPC-SP15 standard, and apply zinc-based primer and protective finish coating to the repair area.

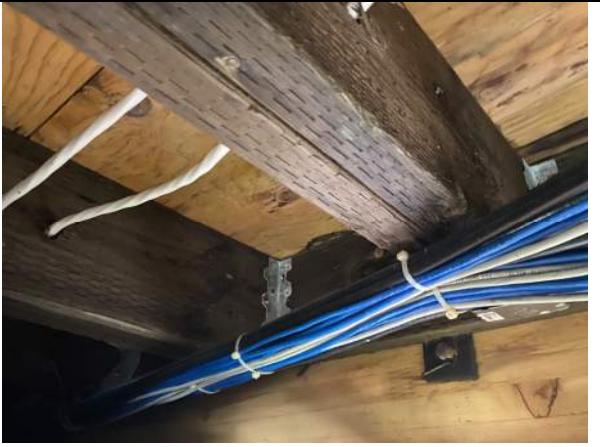
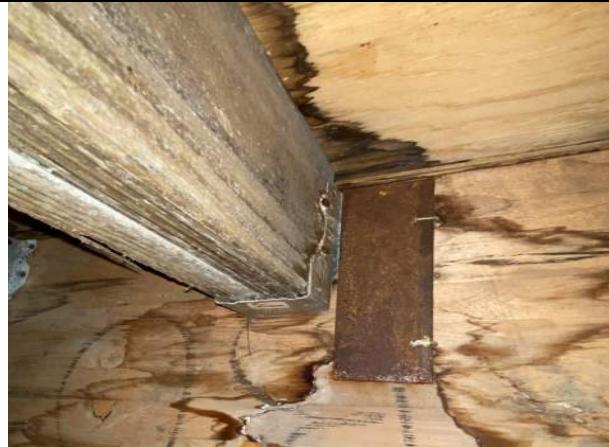
29: Stair by Elevator #3 (opened next to unit 218 from below)

3.2.2.1. Walkway beam water damage (by unit #216). Repair details for observed damage are similar to the repair provided in Appendix E.

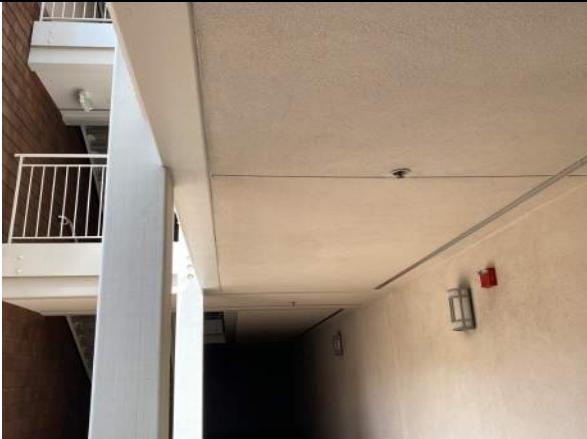
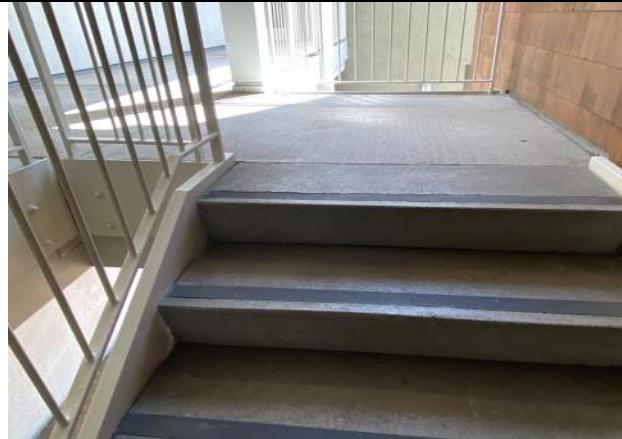
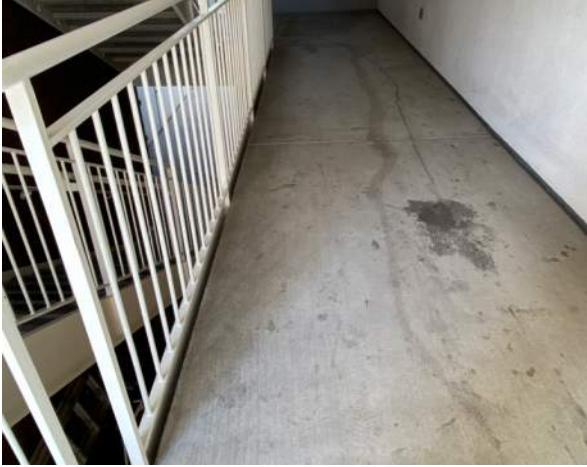
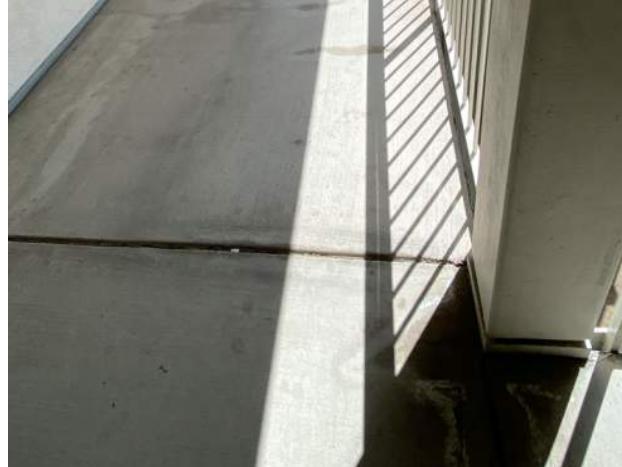
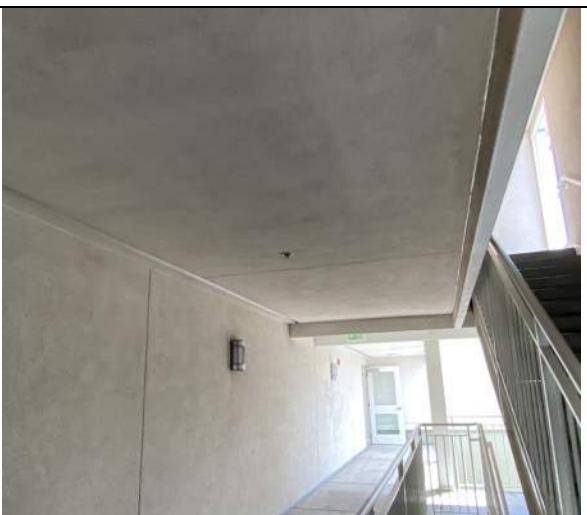
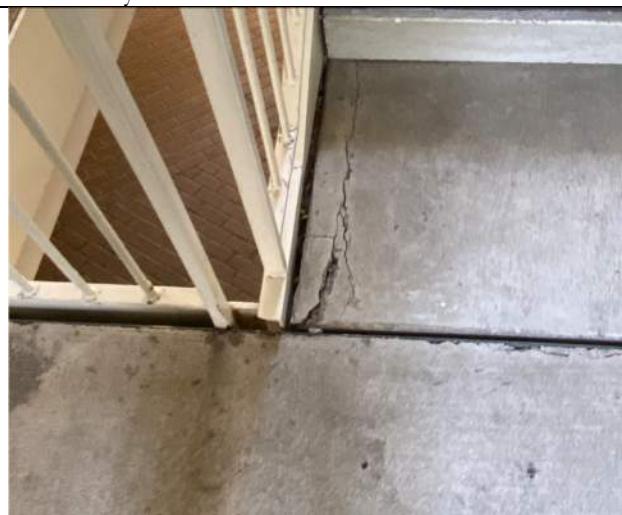
31: Stair by Unit 220

3.2.2.2. Concrete topping cracks greater than 1/8". Patch the existing crack with concrete to avoid further water intrusion into the structural framing below.

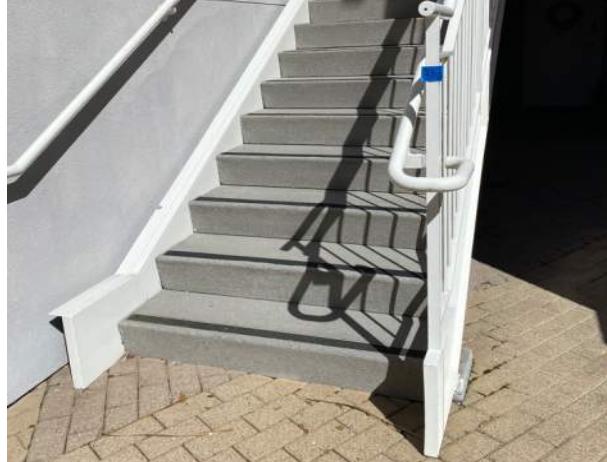
49: Stair by Unit 236

Stairs	Damage Observed	Repair Recommendation
by Unit #201	Rusted Steel plates below concrete thread	See 3.2.1.1
by Unit #210	Rusted steel plates below concrete thread & rusted steel stringer	
by Unit #236	Rusted Steel plates below concrete thread	
by Unit #248	Rusted handrails and blusters	
by Unit #250	Rusted Steel plates below concrete thread
